HISTORIC STRUCTURE REPORT

FURE'S CABIN

BAY OF ISLANDS, NAKNEK LAKE

KATMAI NATIONAL PARK & PRESERVE

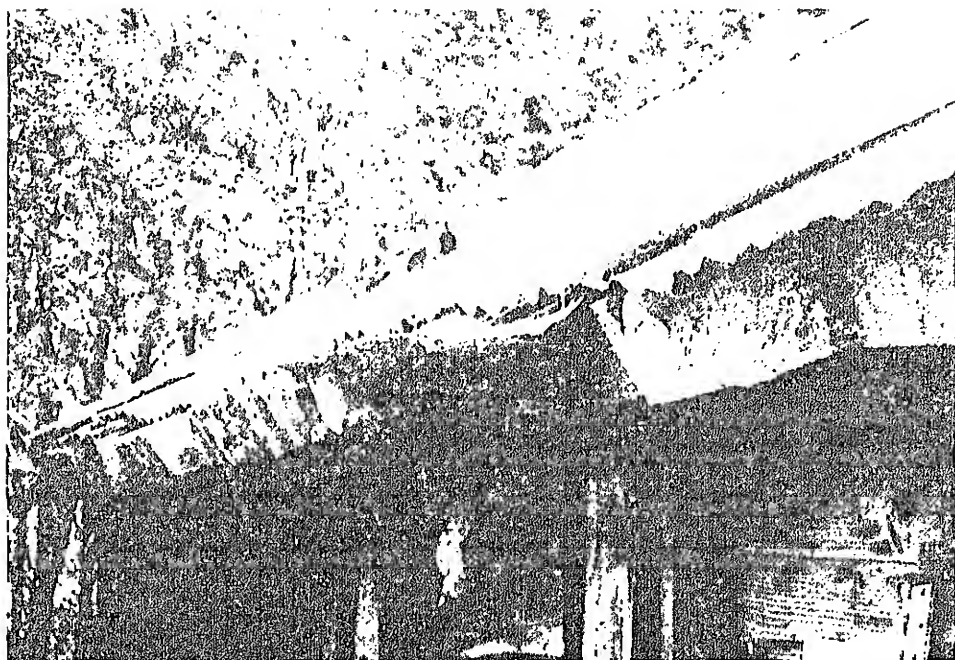
The roof planks are sheathed with corrugated metal at the exterior. There are signs of rot at the butts of many of the planks because the corrugated metal does not uniformly cover the last inch of the plank. Water running off the roof is being soaked up into the end-grain and causing damage. It should be noted that the end-grain of the roof planks and the corrugated metal have all been treated historically with what appears to be red paint, similar to that found on wall corners.

Photograph 11
Roof Planks Ends at East
Elevation
6/28/83 D.C. Anderson

- 9) Once corrugated roofing is removed, inspect roof planks for extent of deterioration.
- Roof Repair 10) Replace with new ones any roof planks that have lost structural integrity (loss of more than 30% of thickness). Hand hew new planks on the exposed underside. Retain roof planks judged in acceptable condition and remove dry rot with hand tools.

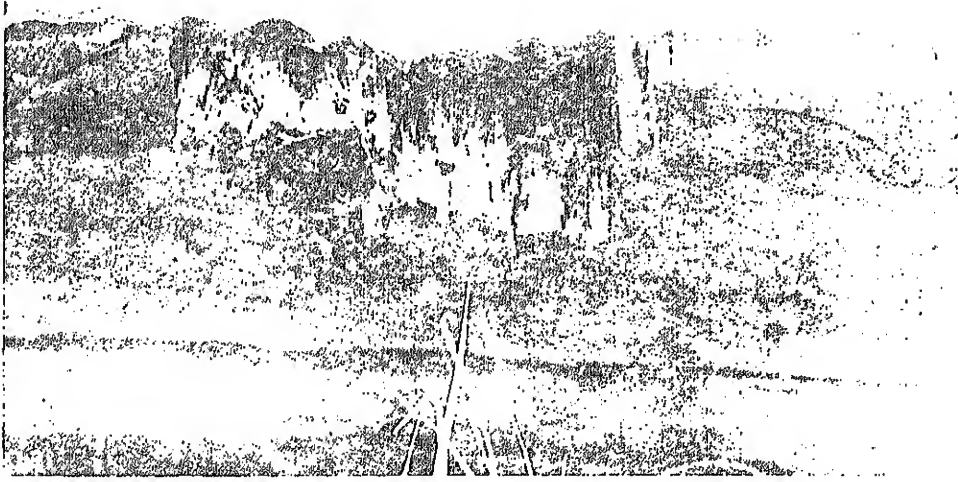
There is also visual evidence of a roof leak at the north end of the west wall that is directly affecting floor planks in that vicinity. Planks are generally mushy near sill walls and bearing points evidencing direct moisture contact.

Photograph 16
Roof Plank Edge at North End of
West Elevation
6/28/83 D.C. Anderson

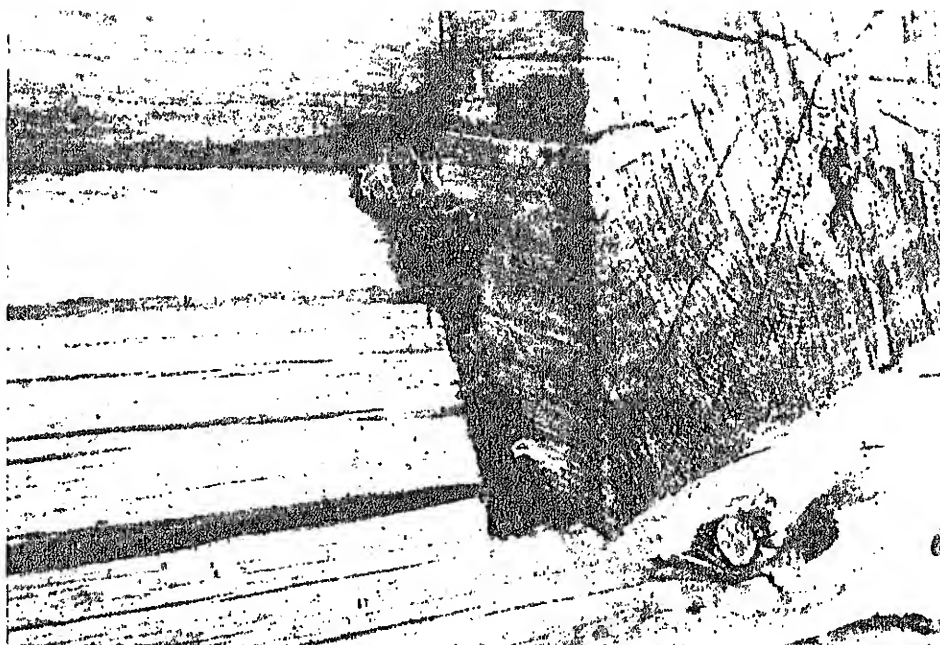
The corner joints are all dovetailed with a high degree of craftsmanship and still fit tight. At various points there is evidence of large spikes having been driven into the dovetailed joints. All end-grain of these joints is painted with red paint. The paint appears to have been a regular maintenance operation in the upkeep of this structure performed by the owner, Roy Fure. The paint has remained in fair condition, thus slowing deterioration at the log butts.

Photograph 43
Typical Dovetail Joint: Note
Paint on End Grain
6/82 D. Snow

- 13) Paint all dovetail end grain with red oxide after priming with mixture of 50% boiled linseed oil and 50% turpentine.
- Window Repair 14) Repair all existing windows: repair broken glass and repairing or restoring sash. Paint restored sashes and glazing compound. (Several weeks may be required for glazing compound to set up.)

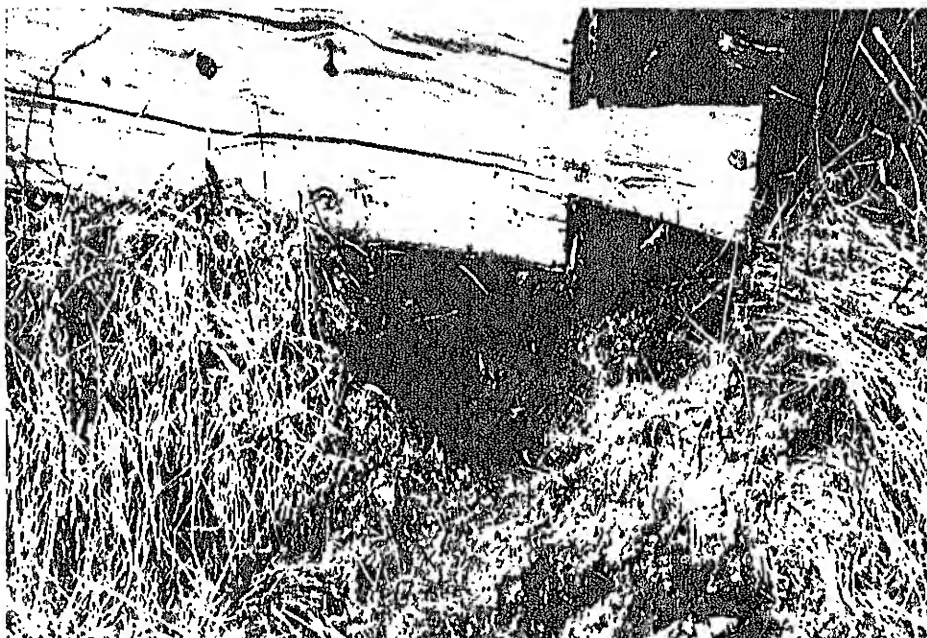
The existing condition of the sill logs is obvious because they have been in constant contact with the soil since the cabin was constructed. There is uniform dry rot primarily below the grade. This problem is compounded at the north elevation and the north end of the west elevation because the structure is built into the hillside. At least three courses of these wall logs, above the floor level, are in direct contact with soil at their exterior face.

Photograph 44
Northeast Corner: Note
Rotted Sill Log
6/82 D. Snow

- Inspection 1) When the entire structure is up on jacks and screws, inspect the sill logs for contamination by decay. If more than 50% of the log is rotted, or decayed below the grade, consider it to have lost structural integrity.
- 2) Remove sill logs that have lost their structural integrity and replace with pressure-treated timber (Douglas Fir) as indicated in Stabilization Drawings.
- New Footings 3) Lay a 10 inch by 10 inch pressure-treated timber under all walls with the top surface level with the floor planks on this member so the finish height is established at this time. Set the 10 inch sill timber on level but undisturbed soil. Lay foundation drain on uphill elevations with 90° elbow at north west corner. Backfill with gravel according to treatment drawings.

- Wall Repair 4) Replace any wall timbers, that require it, with non-pressure treated logs (spruce) insuring that tool marks and dovetailing match level of original craftsmanship. Pressure treat wall timbers that will be in contact with soil. (Douglas Fir)

- 5) Drift pin new sill logs according to drawings.
- Inspection 6) Inspect all existing floor boards and central beams for rot, and if at least 50% of a board's thickness remains, it should be reused. With woodworking tools remove all damaged and rotted wood down to solid material.

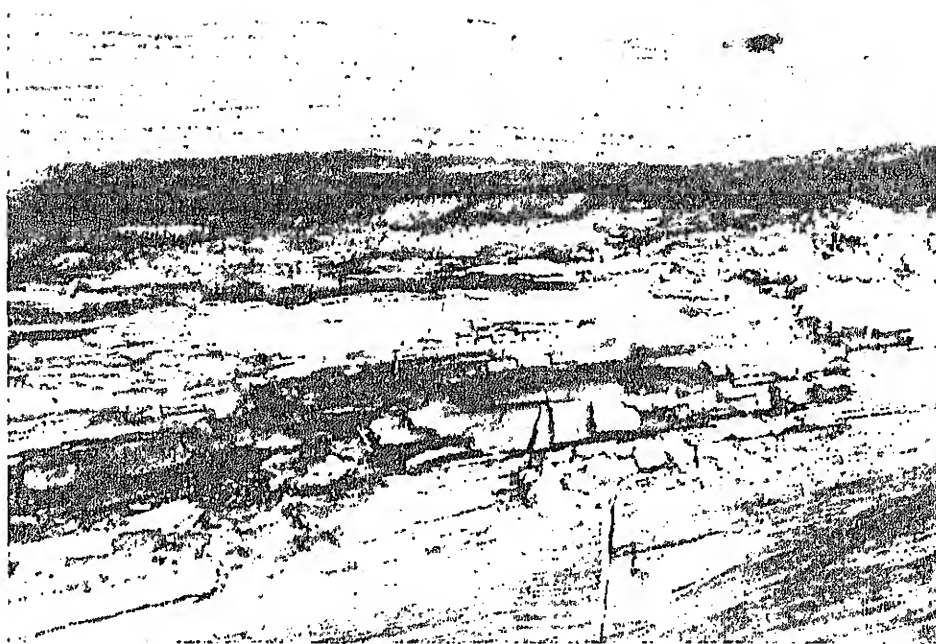
Photograph 48
North Elevation of Cabin Above Window:
Note isolated Dry Rot
6/82 D. Snow

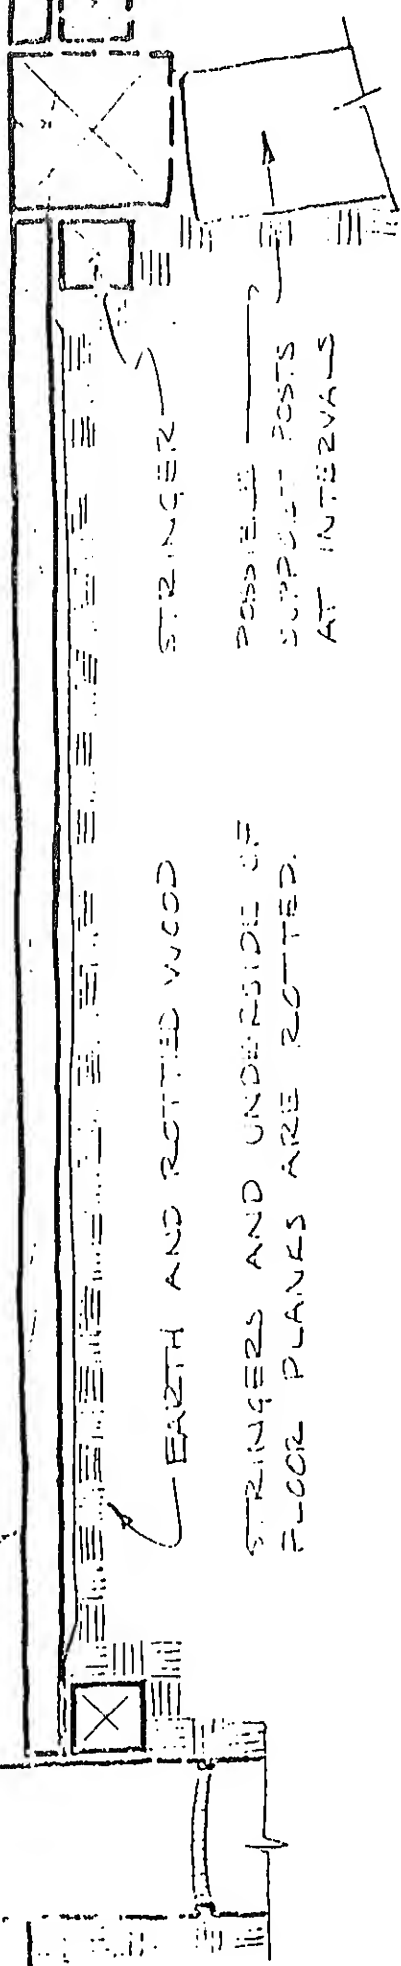
The southeasterly or front half of the wood plank floor of the cabin settled and become uneven, probably caused by both rotting and settling of the plank supports. The floor is pitched and uneven and at one location there is perhaps a 4 inch difference from the surface of one plank to the adjacent one. A brief investigation at this location gave some clues as to the construction of the supporting members of the flooring. The attached sketches show possible constructions, but these are in part, conjecture, as only a small area beneath the planks could be felt.

EARTH AND ROTTED WOOD

STRINGERS AND UNDERSIDE OF
FLOOR PLANS ARE ROTTED.

Each plank should be numbered for positioning with a marker that can be removed or will not be seen. Take up the planks and remove major rot from undersides. Inspect planks to determine those that cannot be reused.

Remove sufficient earth and rotted wood particles to provide an air space below the planks when replaced. Disposal of this material should be in a manner and location to be unobtrusive.

Inspect construction and condition of plank support system to determine what must be replaced. Take measurements for replacement members.

If bearing for stringers is inadequate, it may be desirable to put in a bed of beach gravel or sand under wood blocking or rock supports. Set and secure new stringers and/or ledger boards. An additional stringer should be placed under the planks at mid-span since the rot has reduced the effective thickness and the earth no longer will support them. (Consideration was given to laying in a 6 mil minimum thickness polyethelene moisture barrier, bringing up vertically against the walls and center beam. However, this standard approach may be detrimental by trapping moisture within the air space under the planks.)

Replace original and new planks in their proper locations and secure in the same manner as originally done (if any).
